ACTION MEMORANDUM

SUBJECT: Approval and Funding for a Removal Action at the Red and Bonita Mine Site in San Juan County, Approximately Seven Miles North of Silverton, Colorado.

The purpose of this memorandum is to request and document approval of the removal actions described herein for the Red and Bonita Mine Site (Site) located in unincorporated San Juan County, Colorado. This time-critical removal action involves installing an engineered reinforced bulkhead (massive plug) to stop the flow of the contaminated water coming out of the mine adit. Conditions existing at the Site present a threat to public health and the environment and meet the criteria for initiating a removal action under 40 CFR §300.415(b)(2) of the National Contingency Plan (NCP).

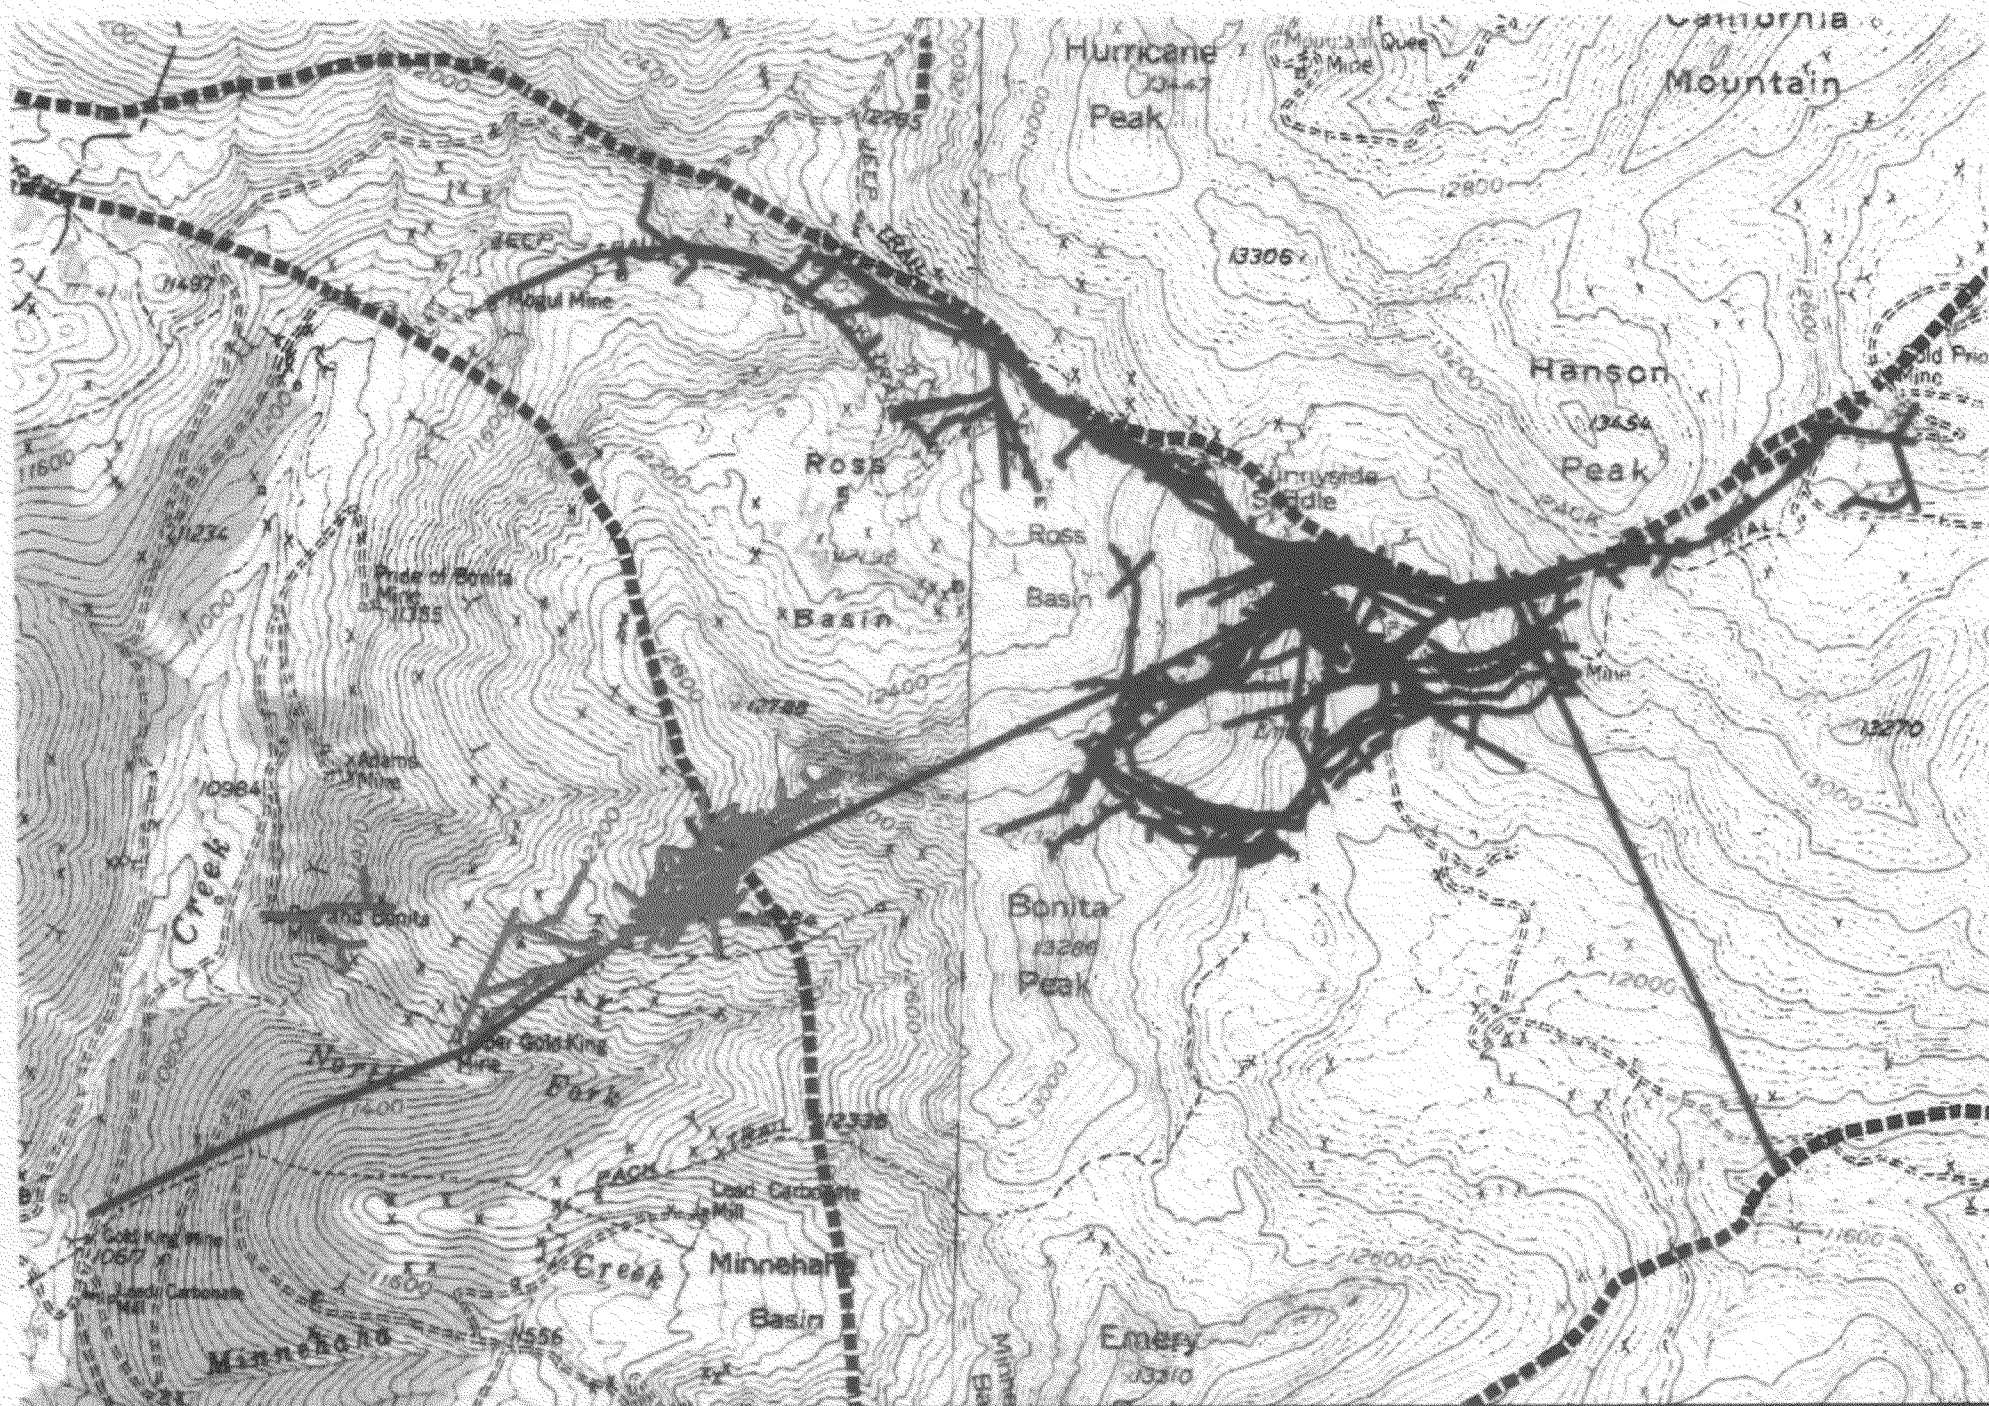
RED AND BONITA MAP
 Mine Workings past cave-ins are only projected to line of sight
 SUNNYSIDE WORKINGS
 Most Recent workings, needs more work
 GOLD KING WORKINGS

In September/October 2011, the EPA removed blockage in the Red and Bonita Mine opening and constructed a temporary portal for accessing the mine. The mine adit is approximately five feet wide by seven feet high and extends underground for several hundred feet in multiple directions (Attachment 1-Figure 2). Investigations of the mine allowed access to approximately 2,000 feet of workings. Collapsed ground within the tunnels prevented further investigation. However, based on historic

information and the estimated waste dump volumes, it is estimated that there are only approximately 3,500 feet of underground workings and that the adit does not connect to other mines (Figure 3). In addition, there is no mapped surface opening to the mine and none were found during Site investigations in September 2014 or previously.
